Suspect/Counterfeit Items Awareness Training

**U.S. Department of Energy
Environment, Safety and Health
Office of Corporate Performance Assessment**

May 2006

Suspect/Counterfeit Items Training

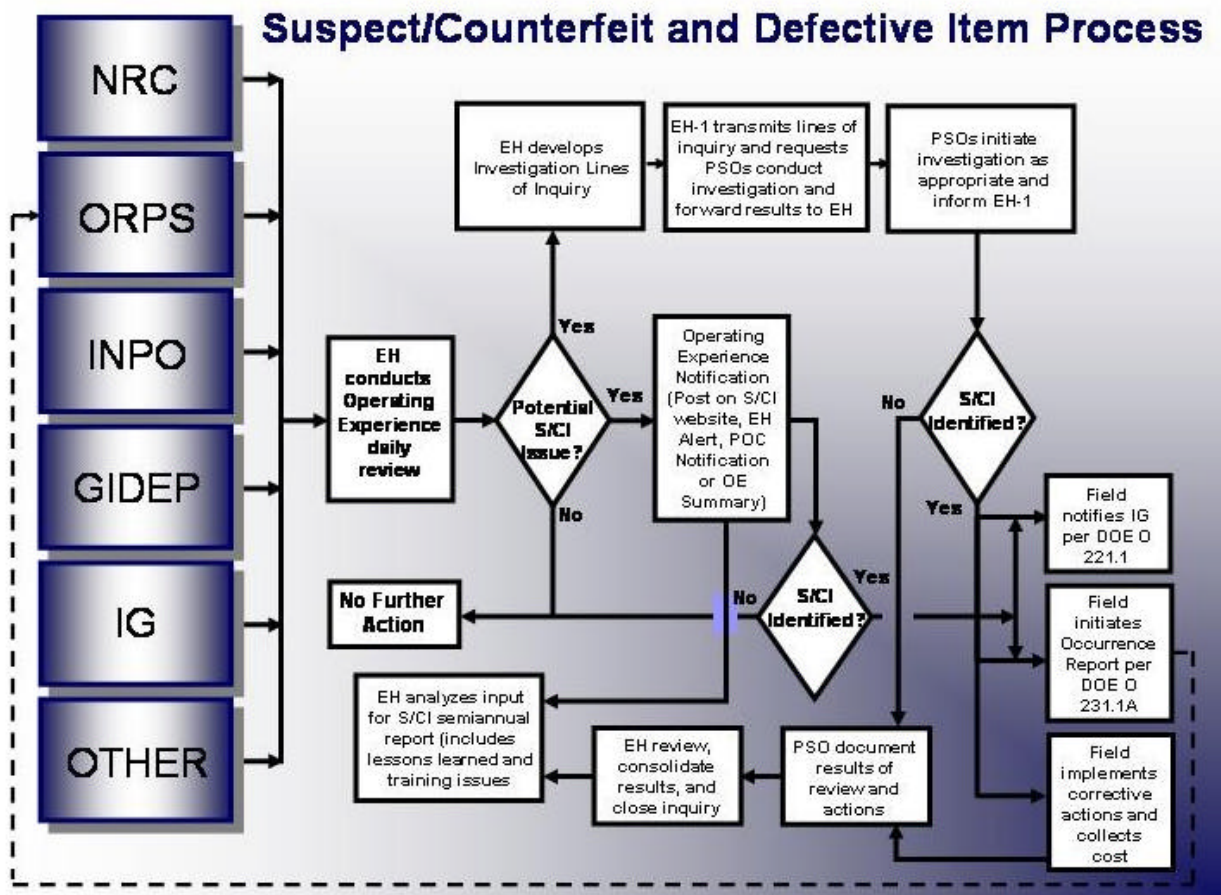
Below is a graphic depiction of the S/CI Process DOE has developed to aid in identifying suspect/counterfeit and defective items.

The S/CI process flow chart is included in the *Office of the Environment, Safety and Health Process Guide for the Identification and Disposition of Suspect/Counterfeit Items at Department of Energy Facilities*. The detailed Process Guide can be found on the Office of Corporate Performance Assessment Suspect/Counterfeit-Defective Items website at <http://www.eh.doe.gov/sci> that includes S/CI-related information and links to other related websites.

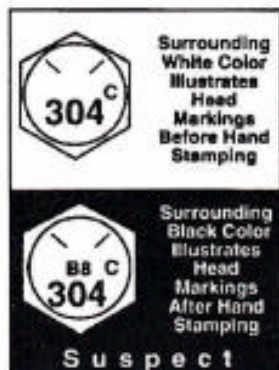
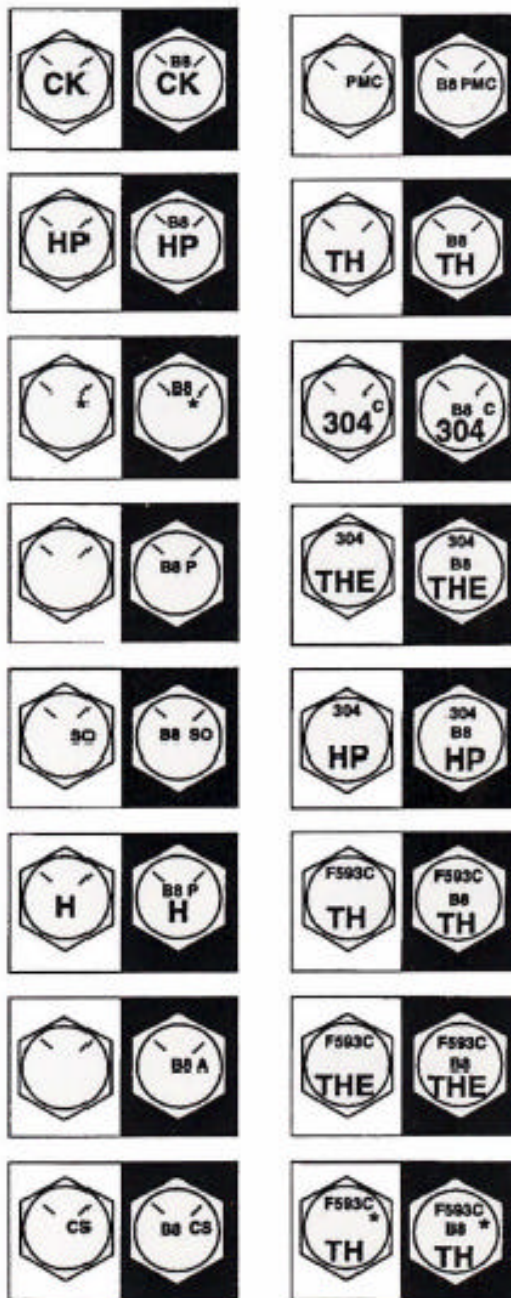
SUSPECT STAINLESS STEEL FASTENER HEADMARK LIST

Examples of stainless steel fasteners that have been upgraded from 18-8 to ASTM A320 or ASTM A193 Grade B8 after hand stamping. The last three examples show samples of fasteners to indicate conformance to two non-compatible standards, ASTM A193 and ASTM F 593C.

Any bolt on this list should be treated as defective without further testing and process in accordance with HNF-PRO-301. Note: This list was originally Published by DOE/EH-0196, Issue No. 97-6

If any of these fasteners are located, contact your facility S/CI Point of Contact (POC) for instructions. The POC list is on the Hanford Intranet at: <http://docs.ri.gov/han.infor/hiansci/hiansci.doc>. Scroll to the end of the document for the list.

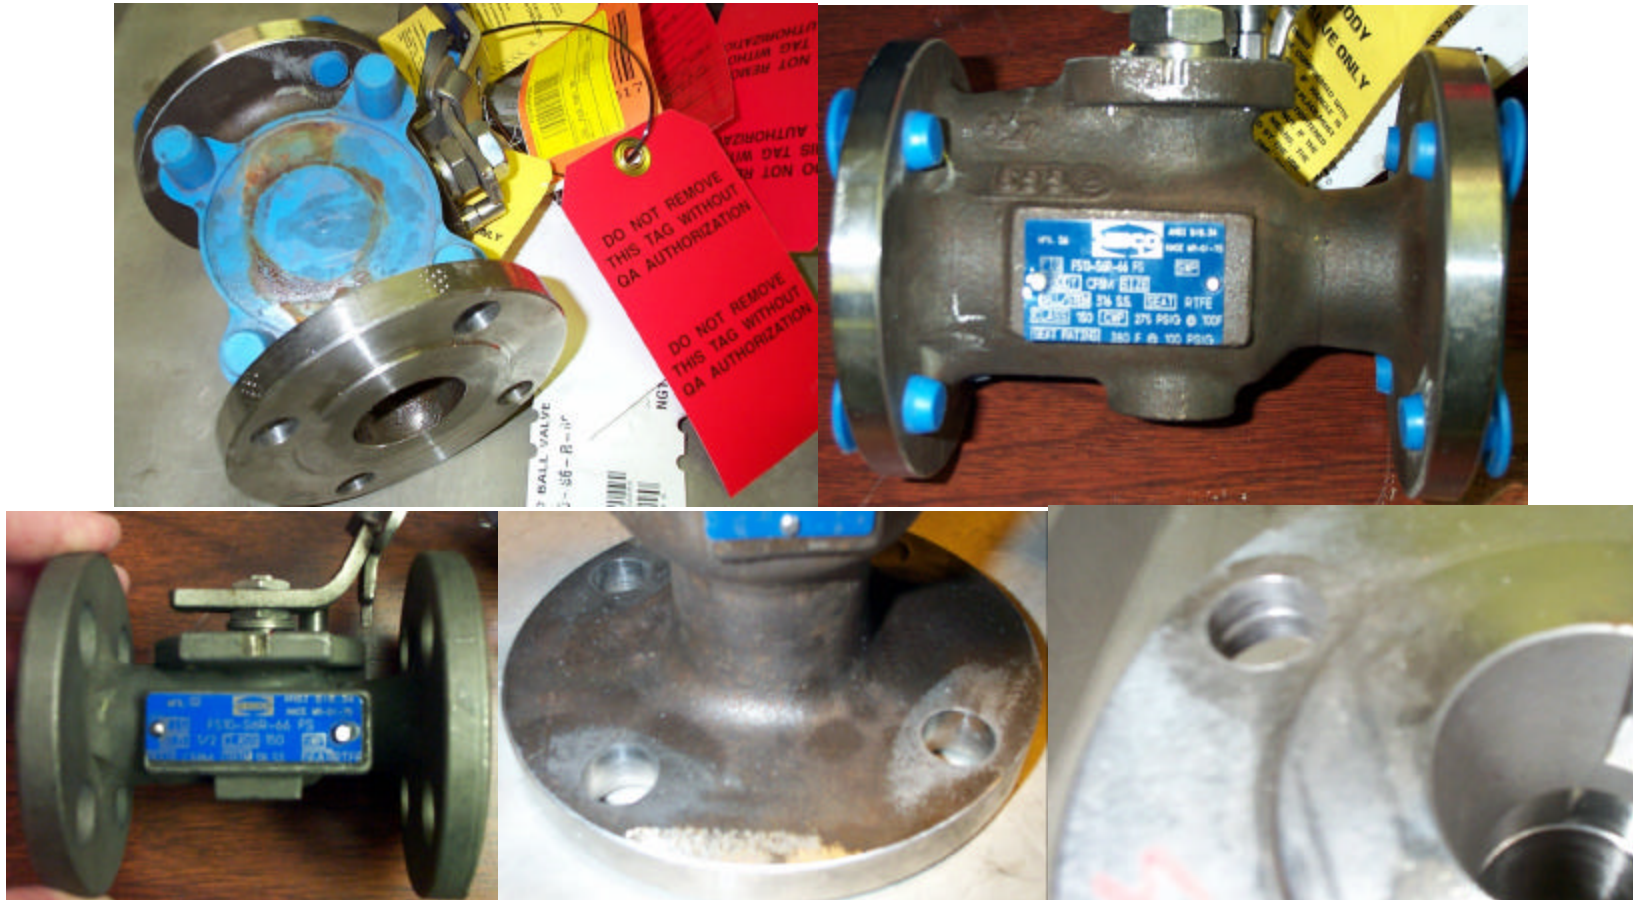
Flanges Received as “New” at the Savannah River Site – Note clamp marks, different rivet sizes on tag, scratches, groove in bolt hole, lack of cleanliness

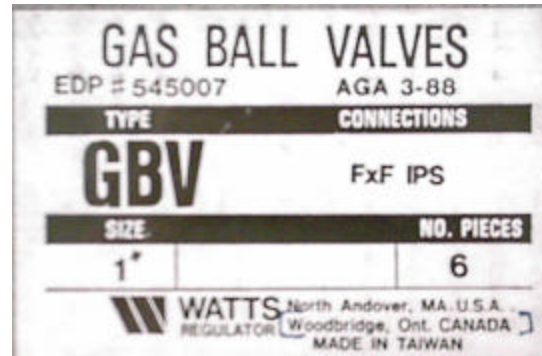
Suspect/Counterfeit Labeling

The WATTS Gas Ball Valve label above is S/CI because WATTS does not have a Woodbridge, Ontario, Canada facility

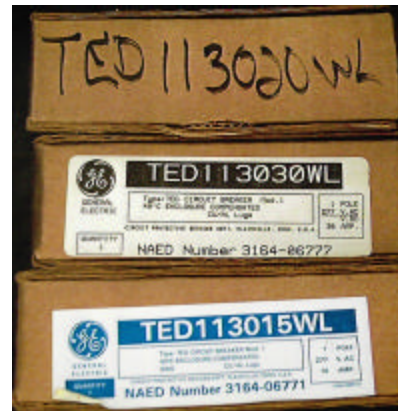
The blue and white colored GE label above is authentic. GE does not affix black and white labels on boxes for this item nor should the product number be handwritten without any proper GE labeling.

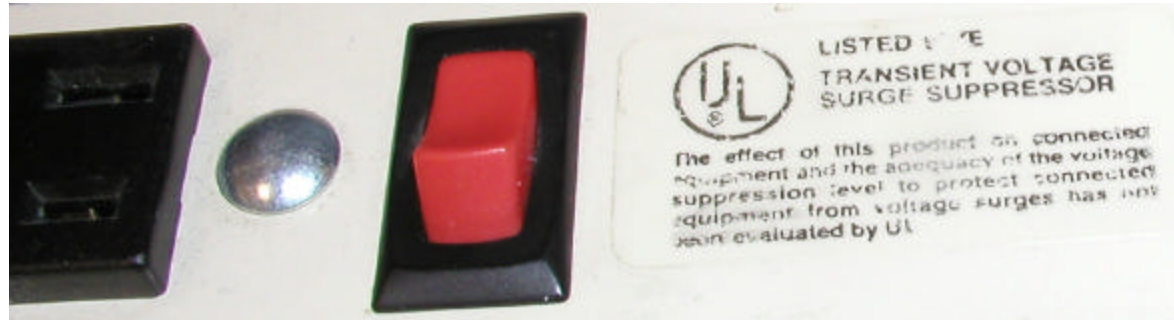
Brooks (Philadelphia, PA) Transient Voltage Surge Suppressor

Found at DOE Headquarters in Germantown, MD

This item was initially deemed “suspect” because of the label statement that reads, *“The effect of this product on connected equipment...has not been evaluated by UL.”* However, discussion with Underwriters’ Laboratory (UL) representatives revealed that this is acceptable language accompanying the UL listing logo. In the guides for product types found on the UL Online Certifications Directory website at <http://www.ul.com/onlinetools.html>, UL states when specific factors have not been evaluated. The guides can be accessed by conducting a Specific Search using the UL Standard Number associated with the product type. The UL standard number associated with Transient Voltage Surge Suppressors is “1449”. After the word “LISTED” on the label, “977E” has been rubbed out. The Model number on the back of the item is VCN-66. The product had been performing as intended when the label statement was questioned.

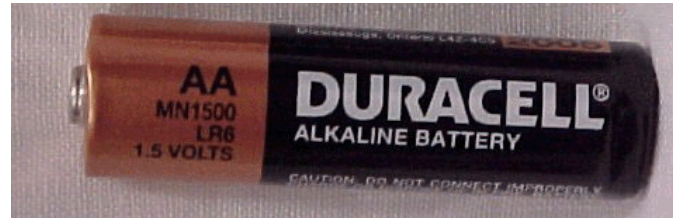
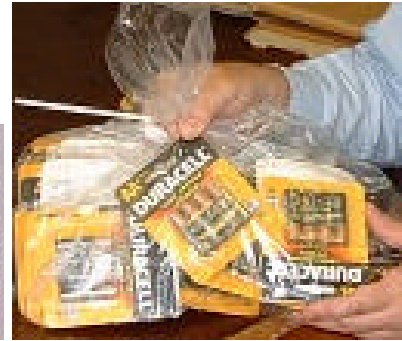
Counterfeit DURACELL® Batteries

Authentic **DURACELL**[®] battery on the left. Counterfeit **DURACELL**[®] batteries on the right spell the name the same as the authentic batteries.

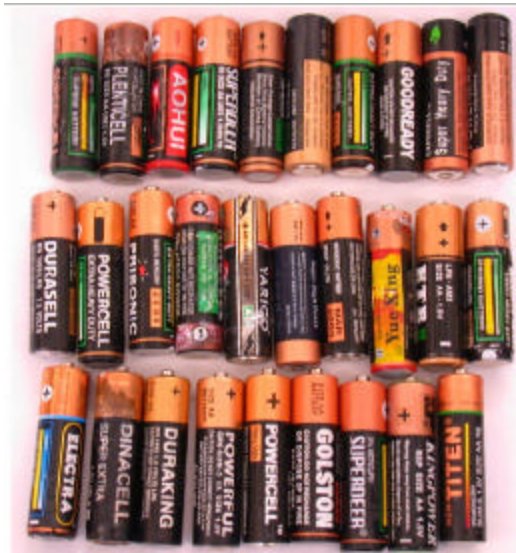
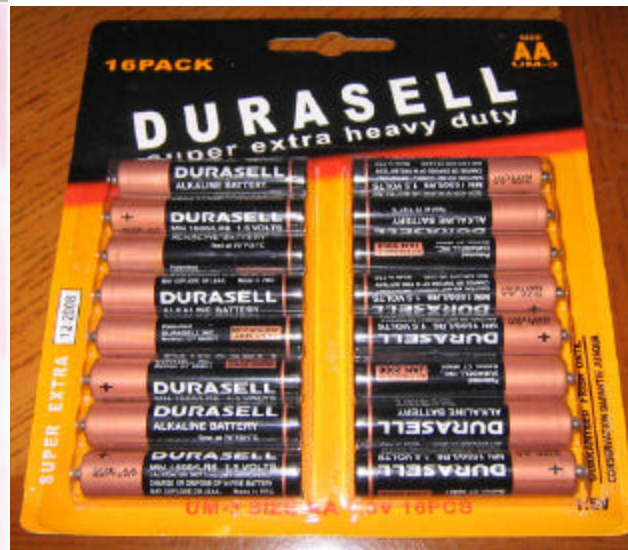
On the left - Examples of DURACELL clones simulating trademarked DURACELL colors (note several are leaking). Some have flimsy casings that crush easily under pressure by hand. The counterfeit batteries on the right the batteries are spelled differently but constitute trademark infringement (black and gold copper top).

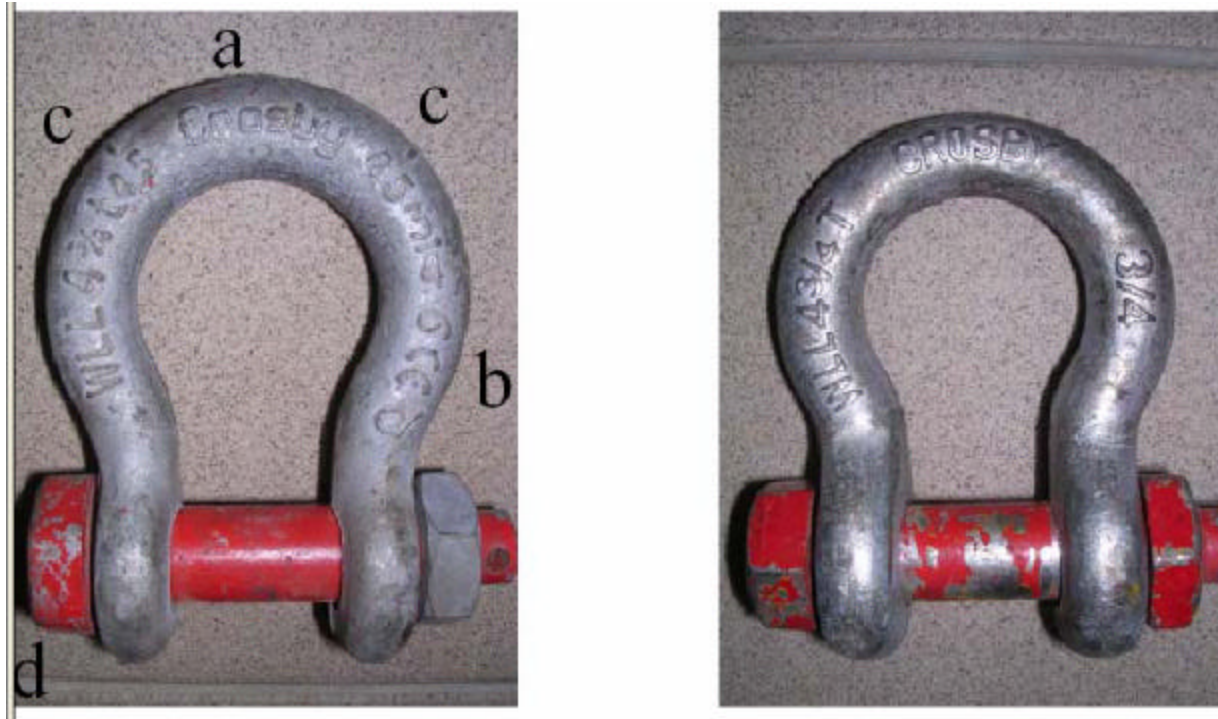
Counterfeit Crosby Shackle found in Europe. Not yet seen at DOE facilities as of early 2006. The one on the left is authentic and the one on the right is counterfeit. Note the spelling of “Crosby” on the left (authentic) with the first letter capitalized and the rest in lower-case letters. a) Crosby name embossed per Crosby logo, b) should see CE mark, c) 45-degree angle markings, d) pin stamped on head with traceable ID number.

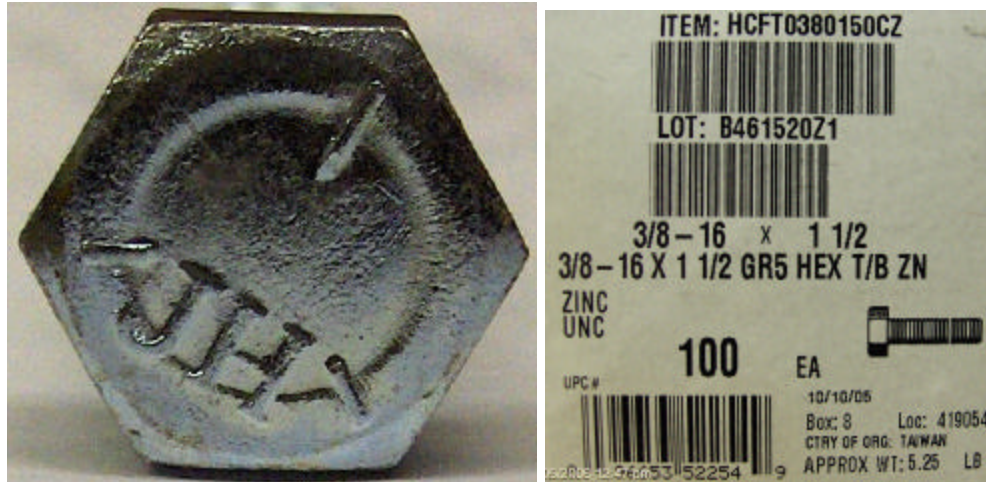
This Jinn Her “JH” Grade 5 Hex Bolt from the West Valley Demonstration Project (WVDP) was received December 2005. Jinn Her “J” headmarks on grade 5 and grade 8 high carbon steel fasteners are deemed counterfeit. However, Jinn Her has the “JH” insignia currently registered in the U.S. through the U.S. Patent and Trademark Office. The fasteners were ordered as domestic, yet the supplier provided the foreign made Jinn Her fasteners from Taiwan. The fasteners were tested and found to meet WVDP specifications. WVDP has chosen to use these fasteners. This insignia (headmark) appears on the FQA Register of Active Fastener Insignias at <http://www.uspto.gov/web/offices/tac/fqa/fqa.htm>.

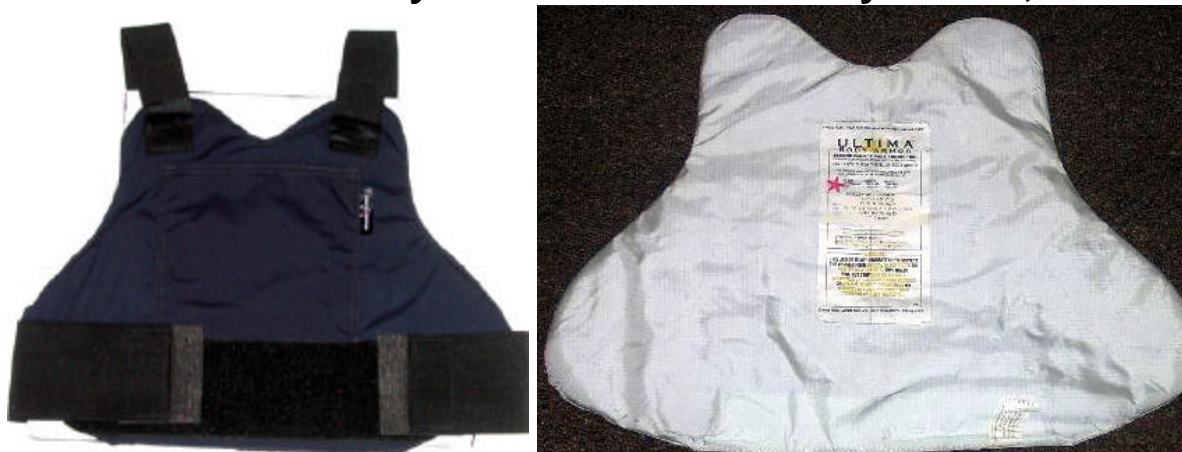
Suspect/Counterfeit Bulletproof Vests Manufactured by Second Chance Body Armor, Inc

Bulletproof vests manufactured by Second Chance Body Armor, Inc. ("Second Chance"), which contains Zylon[®], a fiber manufactured and sold by Toyobo Co., Ltd. and Toyobo America, Inc., and sold by Second Chance and its distributors under the trade names ULTIMA, ULTIMAX, and TRIFLEX. These vests fail to meet the performance characteristics for which they were warranted, degrading at a quicker than expected rate from light, humidity, and temperature. Allegedly, the defective condition of the vests was withheld from the marketplace. Upwards of 20% of the ammunition fired at these vests penetrated the fabric.

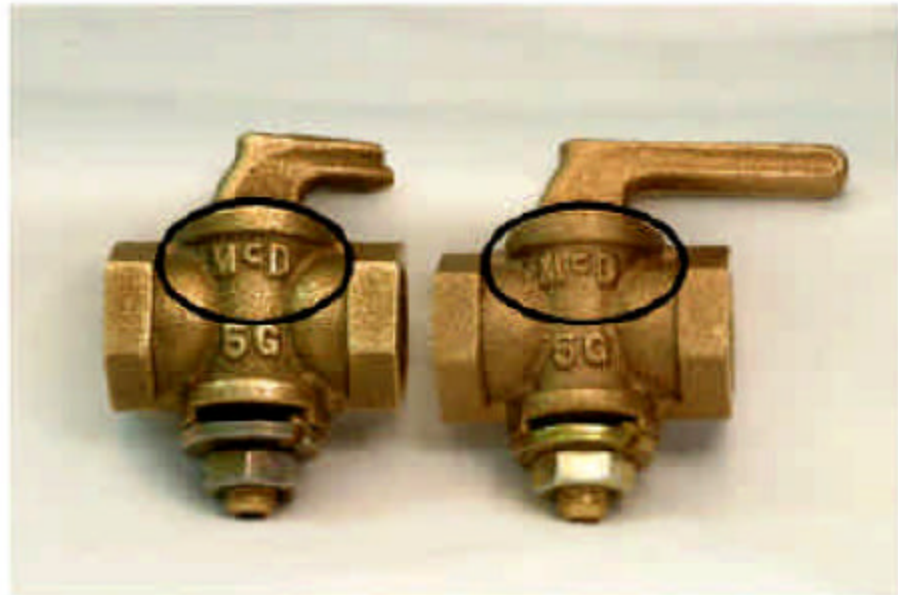
Comparison of ½" Lever Handle with Check low pressure gas valve – Plug style

Left – Counterfeit
Markup similar to McDonald

Right – Good
A.Y. McDonald

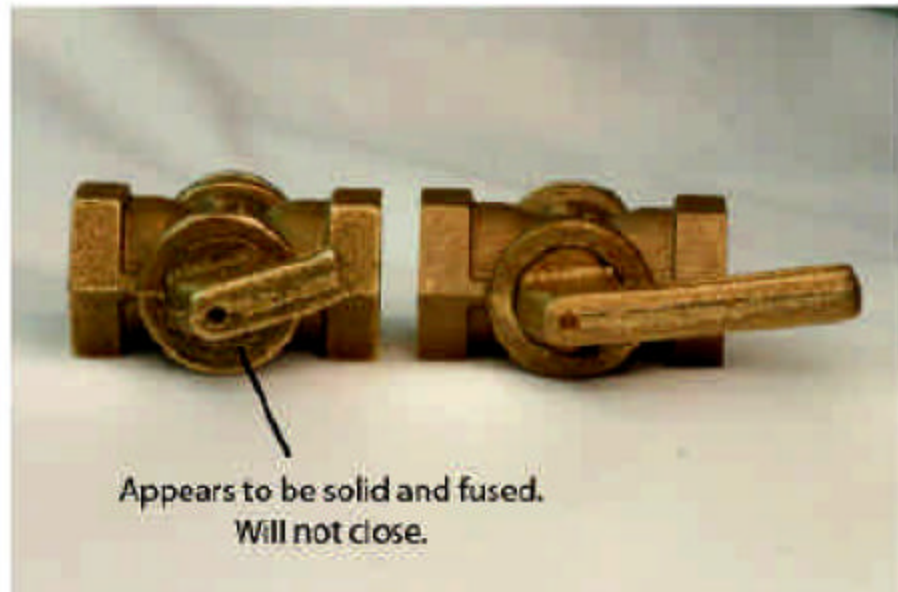
Left – Counterfeit

Right – Good

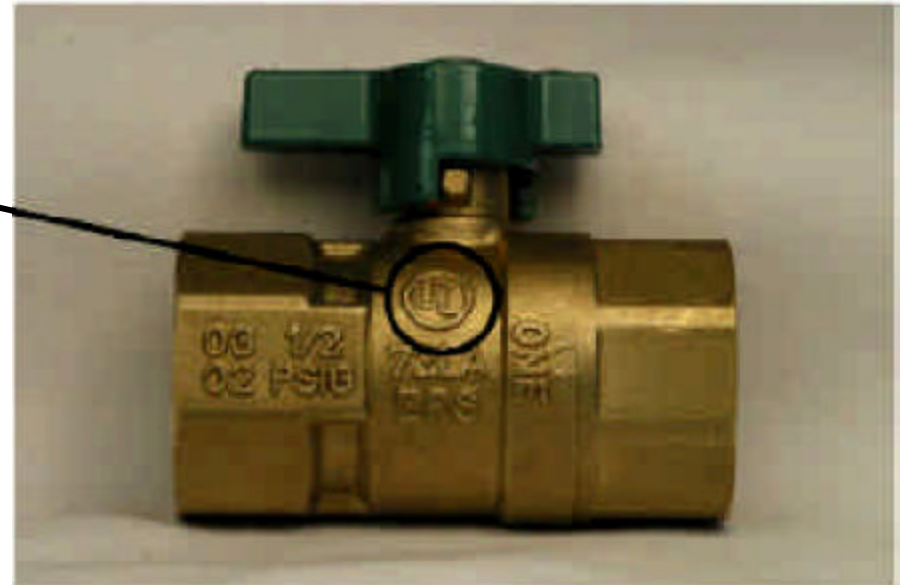
1/2" Forged CSA Ball Gas Valve – Good

UL logo
(Underwriters' Laboratory)

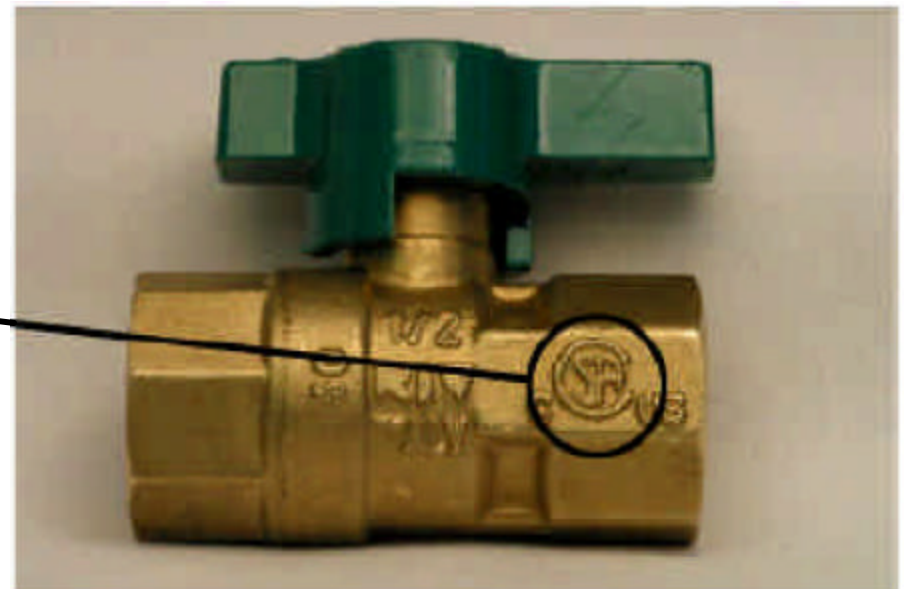
CSA logo
(Canadian Standards Association)

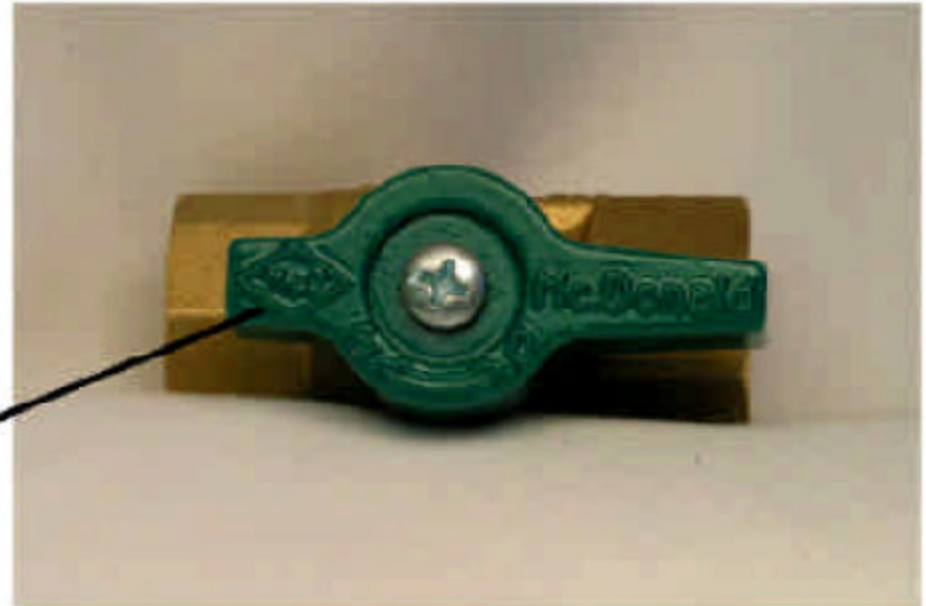
**1/2" Forged CSA Ball Gas Valve
Good**

Top View

McDonald logo

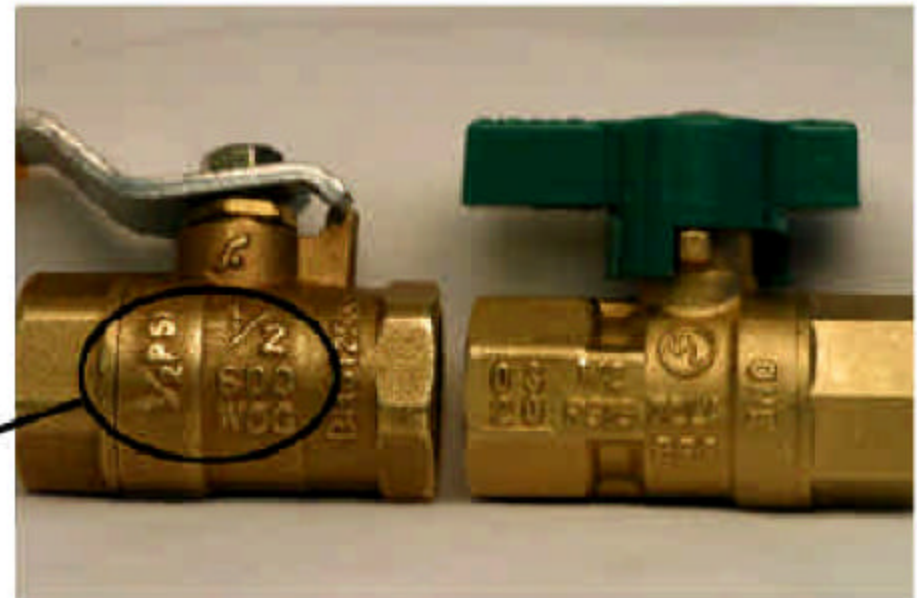
**Comparison between two 1/2" Forged CSA
Ball Gas Valves**

Left - Counterfeit

Right – Good

Conflicting information
1/2 psi – 608 WOG

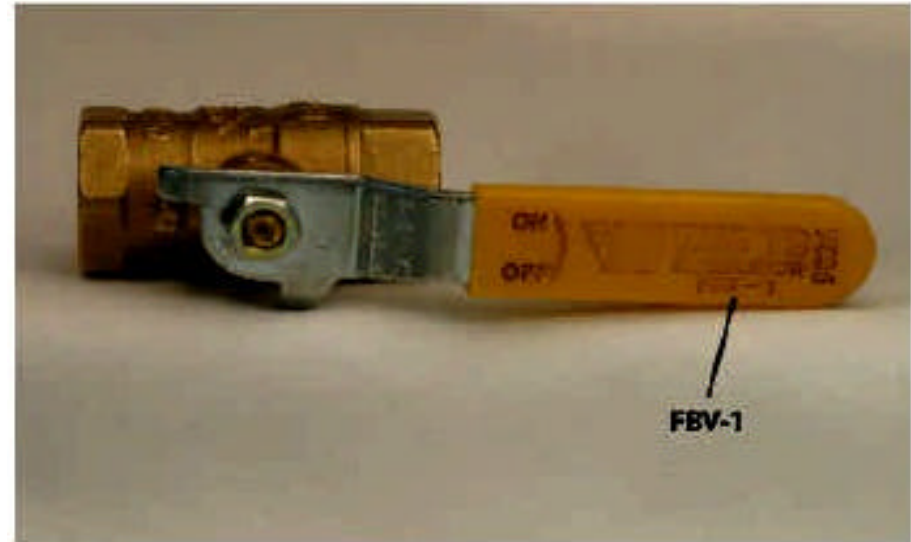
1/2" Forged Ball Gas Valves Counterfeit

Handle marked Watts Regulator FBV-1
Watts doesn't manufacture a FBV-1 series valve.

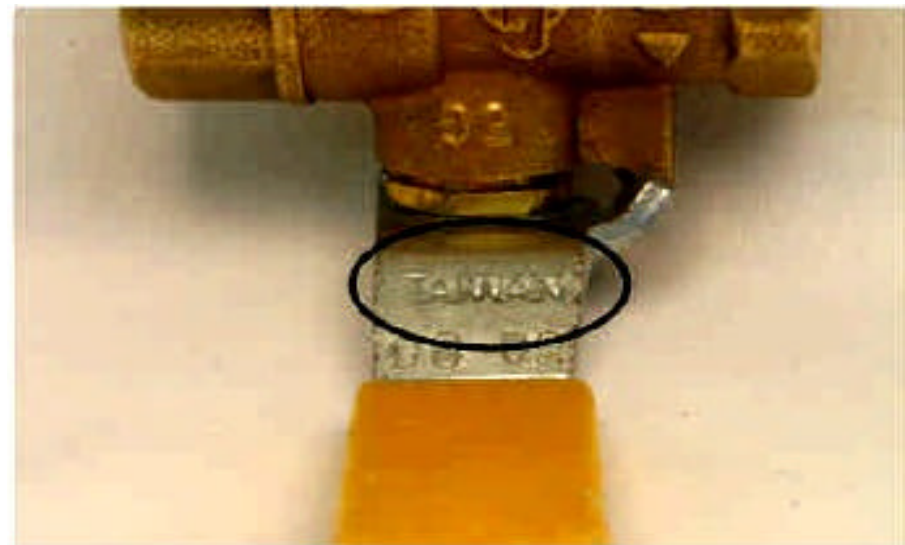
Taiwan stamped on the back of handle.
Watts doesn't have a facility in Taiwan.

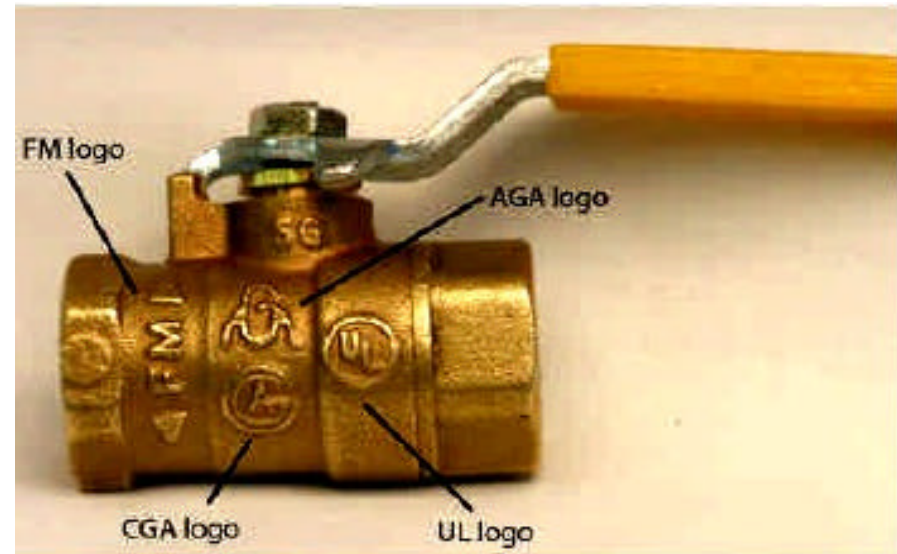
1/2" Forged Ball Gas Valves Counterfeit

Four logos:

- FM (Factory Mutual)
- AGA (American Gas Association)
- CGA (Canadian Gas Association)
- UL (Underwriters Laboratory)

Watts only manufactures to UL and CGA

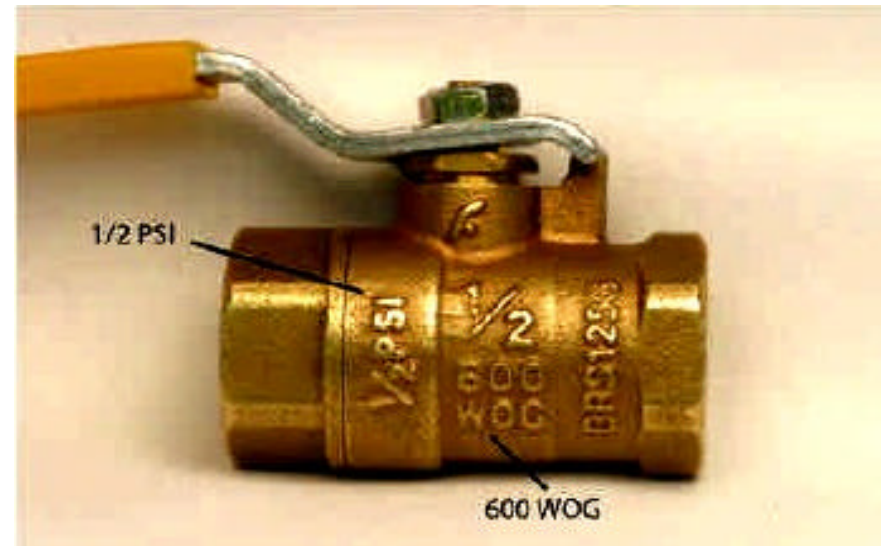
1/2 psi and 600 WOG markings

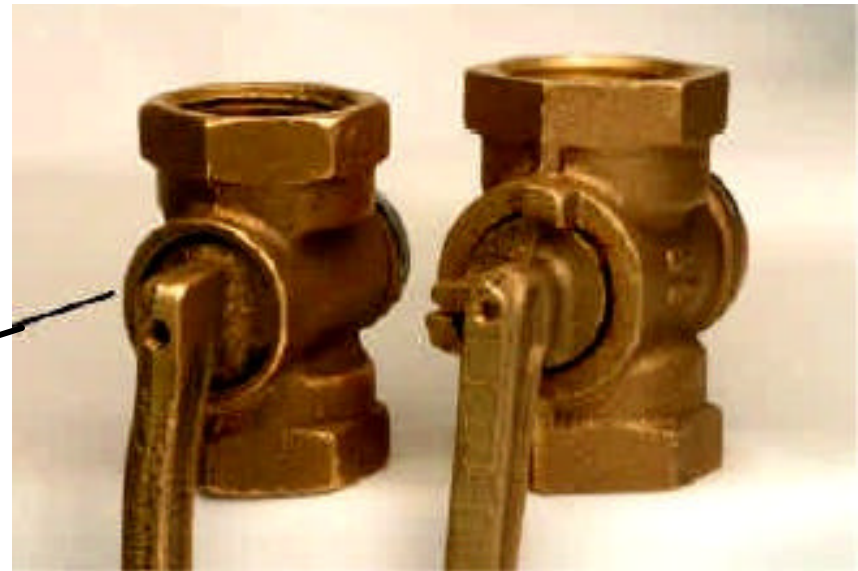
**Comparison of two 1" lever handle with check
low pressure gas valves - plug style**

Left - Counterfeit
Will not close; appears fused.

Right - Good

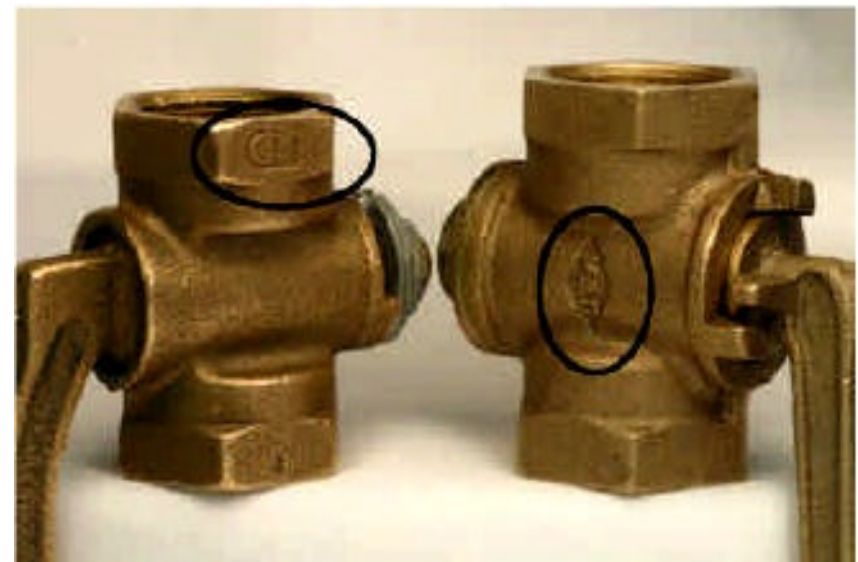
Comparison of markings

Left - Counterfeit
CI (Coalition of Indian Industries)
marking

Right - Good
McDonald marking

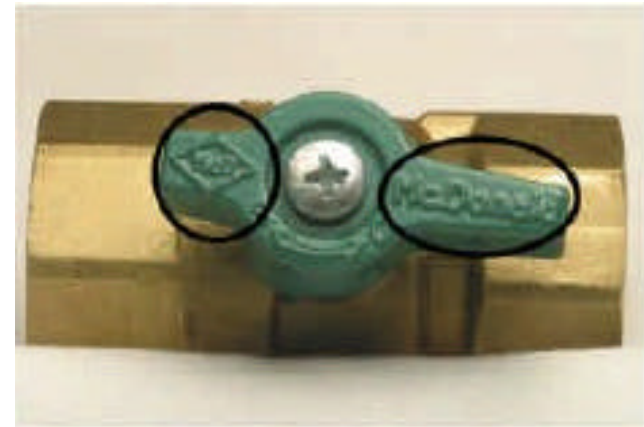
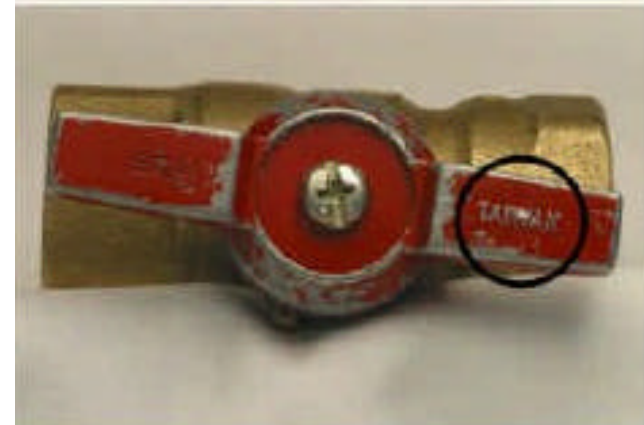
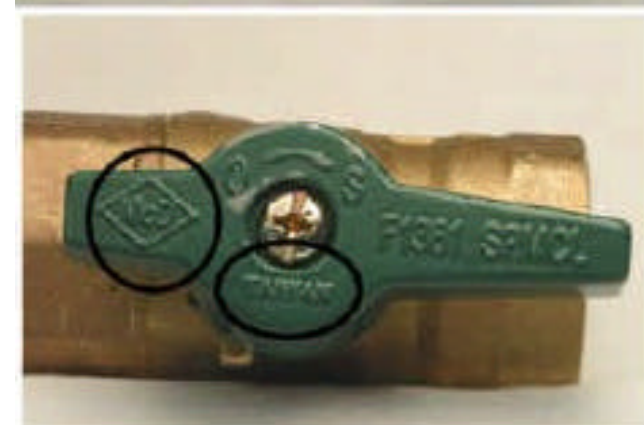
Comparison of three valves
All foreign by indicators on valves
Top - Good
Middle - Counterfeit
Bottom - Good

McDonald manufacturer
Clear manufacturer per standards

Unknown manufacturer

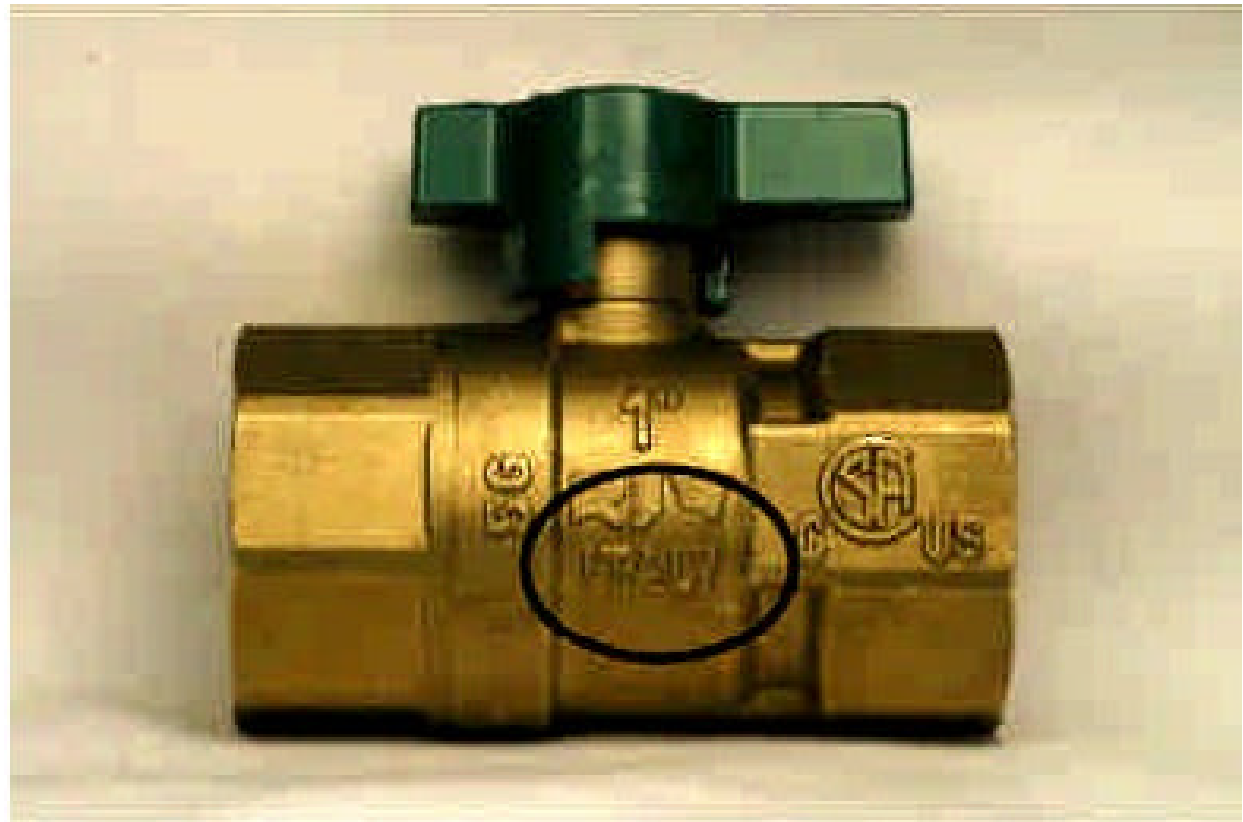
1" Forged Ball Gas Valve
Good

McDonald valve manufactured
in Italy

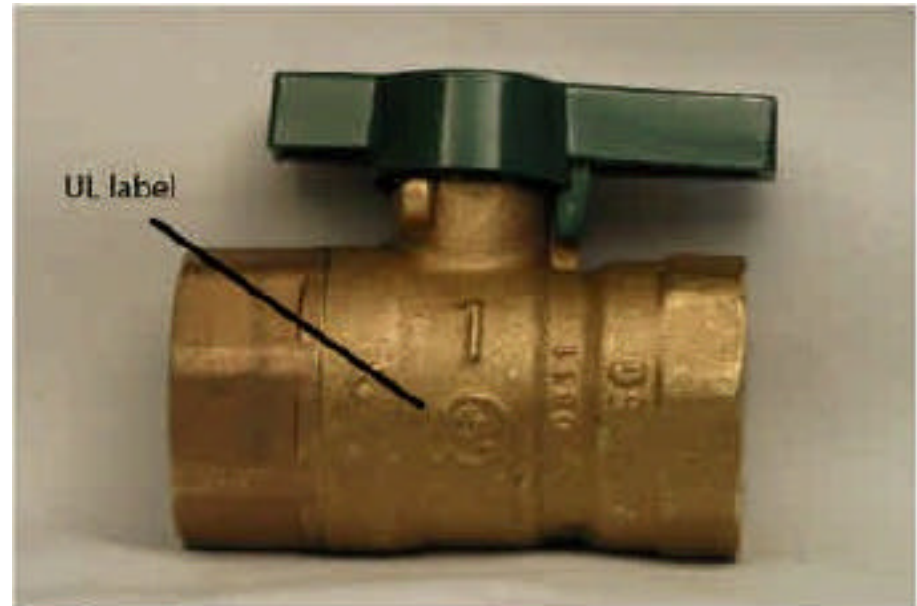
1" Forged Ball Gas Valve
Good

McDonald valve manufactured in Taiwan
UL (Underwriters' Laboratory) label marking
Refer to page 33 for comparison

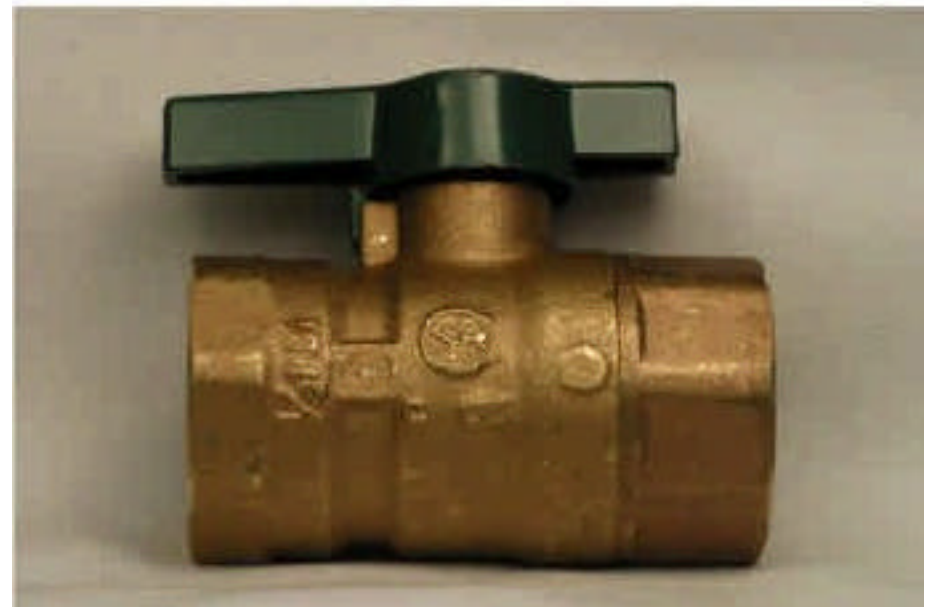
McDonald valve manufacturer in Taiwan
Opposite side view
Refer to page 33 for comparison

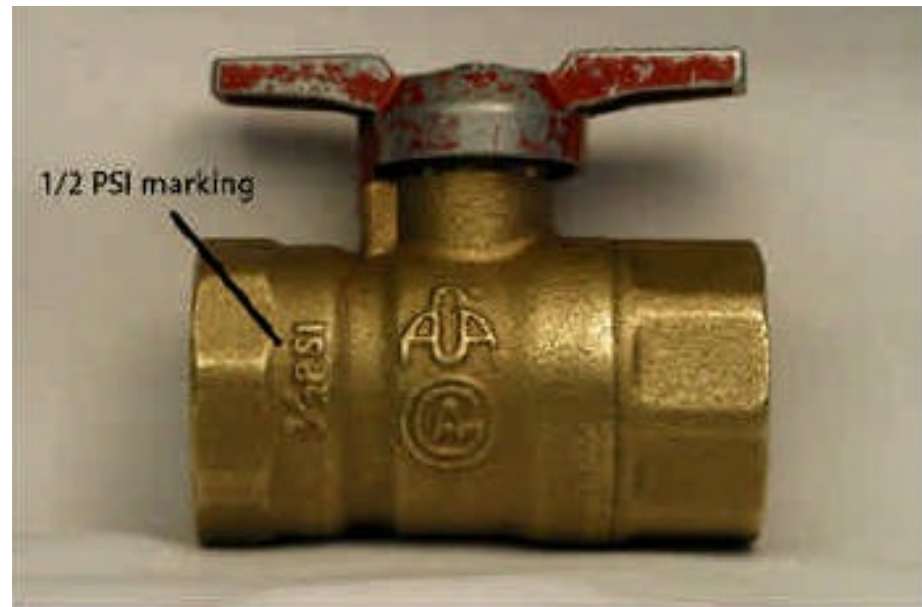
**1" Forged Ball Gas Valve
Counterfeit**

Unknown manufacturer
1/2 psi marking
Represented as new
No manufacturer marking
Refer to page 33 for comparison

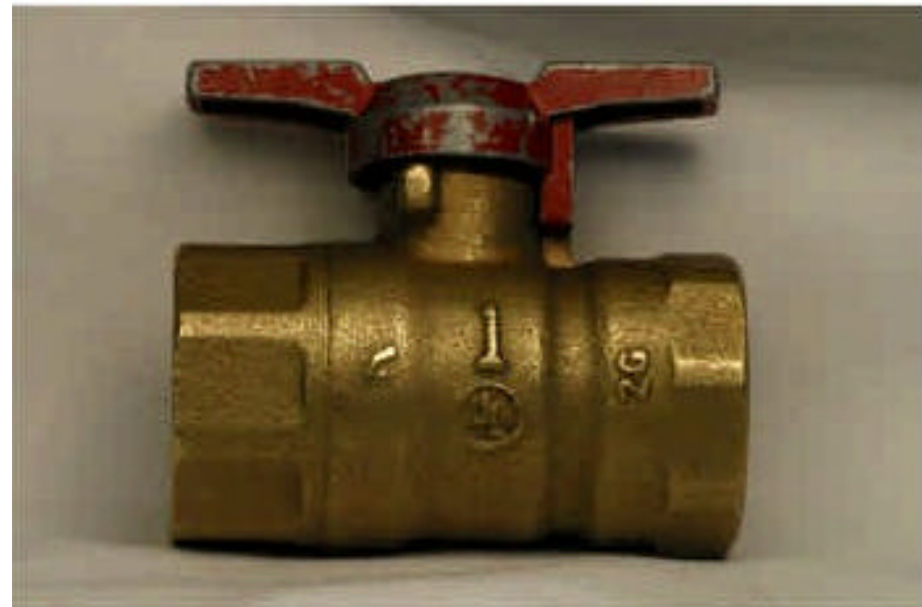
Unknown manufacturer
Opposite side view
Refer to page 33 for comparison

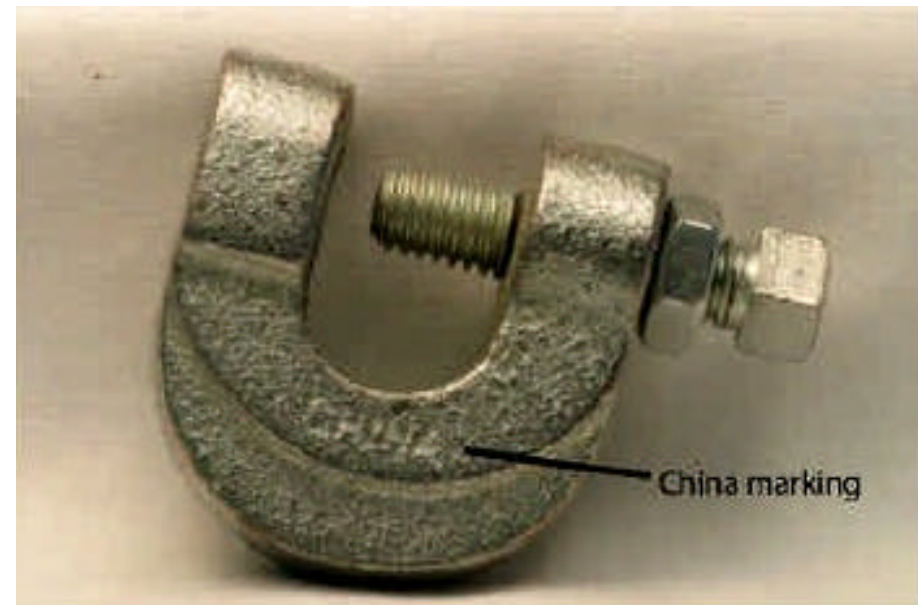
Zinc-Coated Beam Clamp Counterfeit

Product ordered domestic
Label on box indicated domestic
All products inside marked with "China"
No manufacturing name or logo on part
Supplied by a B-Line distributor

For example, the photo of the clamp with the “CHINA” marking and the caption “*zinc-coated beam clamp counterfeit*” on page 42 is the result of research leading to the declaration that this particular clamp is counterfeit. The “CHINA” marking was an initial clue that led to a declaration of the item being “suspect” or “suspect/counterfeit” depending on the site use of the terms, but was not initially declared as “counterfeit.” When conducting research to make a final declaration on an item, it is very often necessary to trace the item back to its origins and look into documents such as purchase orders, contracts and certifications. Subsequently, it is possible that a site might receive a “CHINA” marked clamp such as this and site policy prohibits non-domestic items on the site for use in operations. However, after conducting research, it might be revealed that there was no input from QA or engineering or safety that set specifications or standards for the purchase order and the procurement staff did not seek that information before sending out the request. This then could result in a vague purchase order being generated and sent to the vendor. The vagueness may not preclude “CHINA” marked items from being supplied. The vendor might then supply a “CHINA” marked clamp from their inventory. Further, the contract with the vendor might be silent on S/CI prohibitions. So, the site gets what it ordered, but not what it wanted. In such an example, the item declared initially as “suspect” would not become “counterfeit”, because the error was on the part of the site, and no evidence of intent-to-defraud was identified. Hence, it is important to understand that when viewing a picture such as the “CHINA” marked clamp, it does not mean that all clamps marked “CHINA” are “counterfeit.”

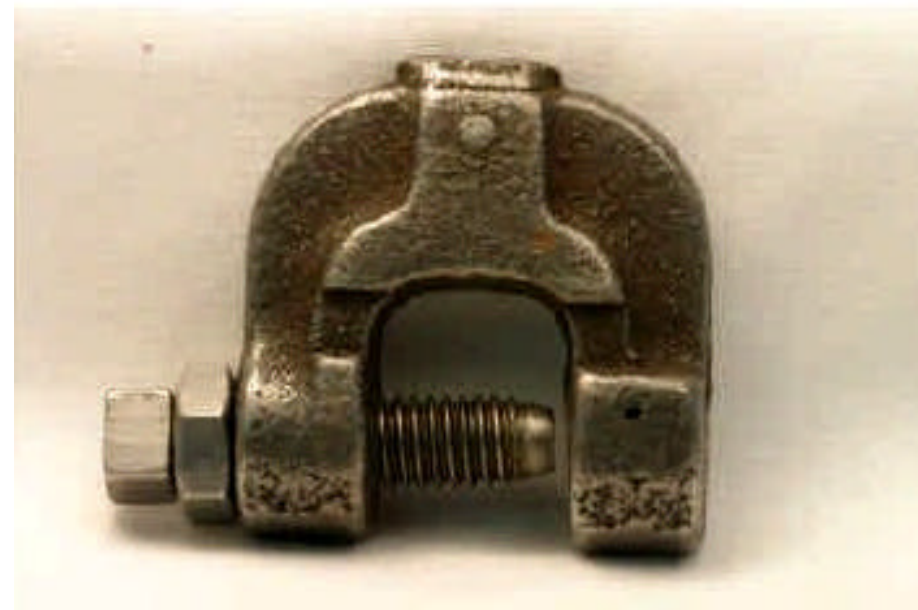
Beam Clamp Counterfeit

No manufacturing name or logo on part
No part number or size

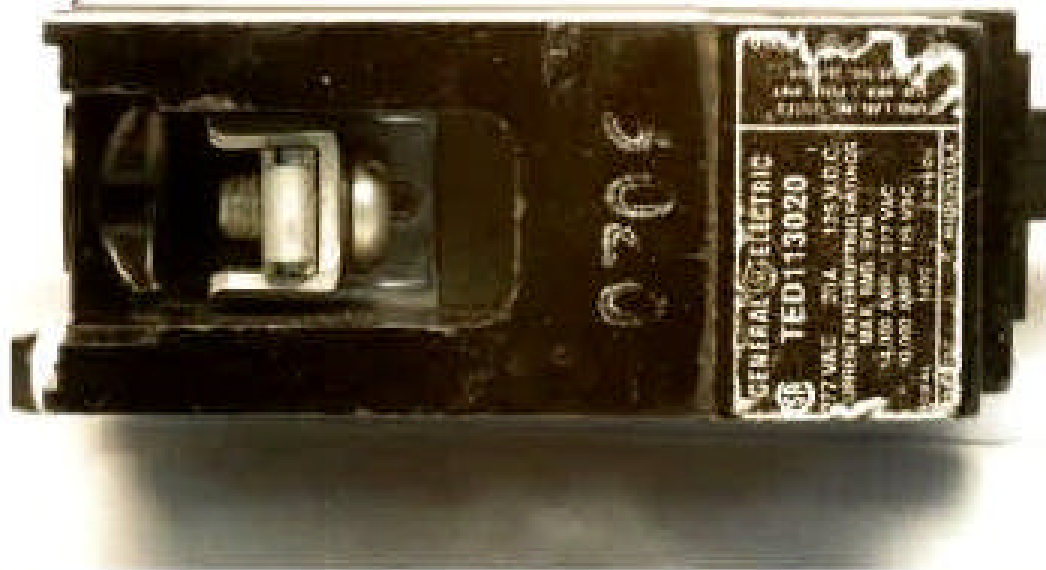
GE Molded Case Circuit Breaker Counterfeit

End view

Manufacturer stopped marking with both indicators over 20 years ago

Label very worn

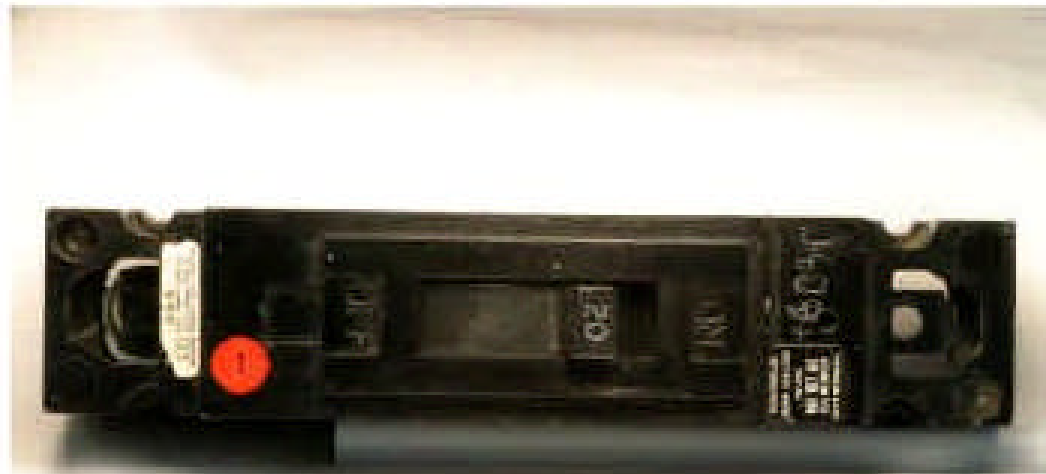
Top view

Represented as being new in condition shown

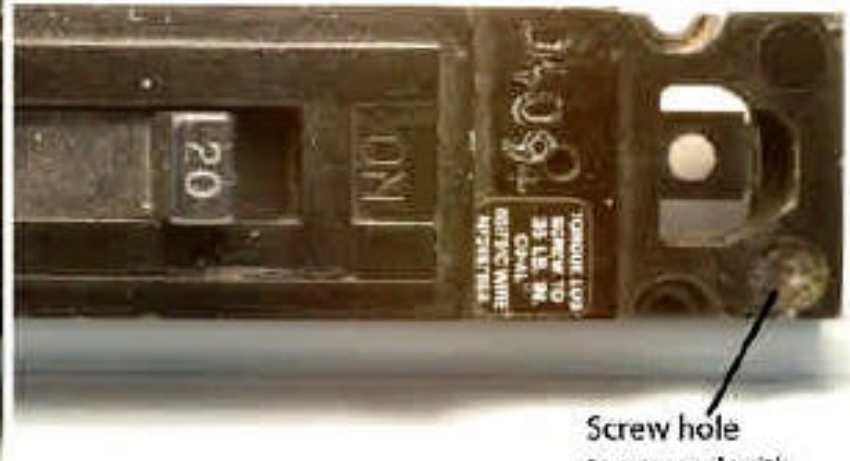
Sold as new by supplier
Indications of being used or refurbished
Label worn and torn

Potting material in bottom screw hole tampered with;
should be smooth and even with surface of case
Appears dirty and worn
Represented as being new in the condition above

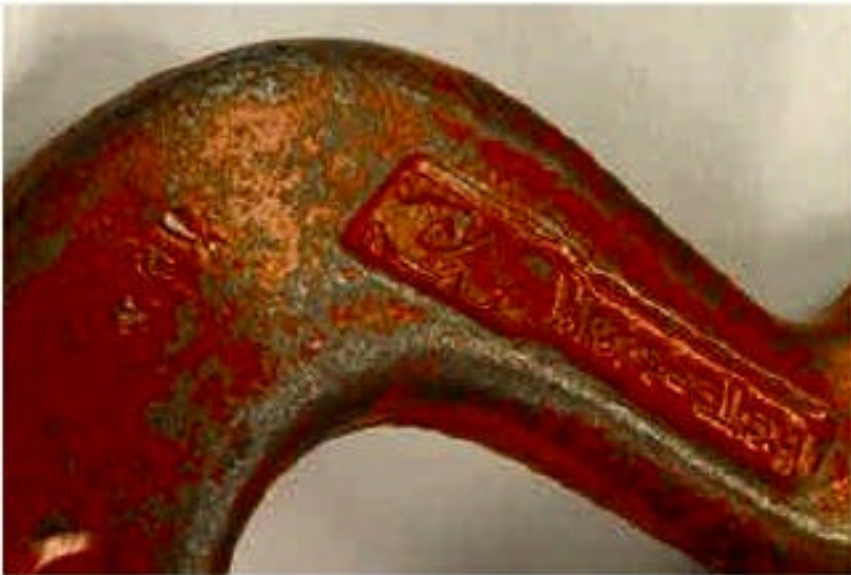
Represented as being new in condition shown above
Appearance very worn
Are correct manufacturer markings for orange hook
